First Assessment of Herat Afghanistan Earthquake: Preliminary Shelter and Housing Response in Zinda Jan District, West of Herat

October 12, 2023

Miyamoto International, Inc.

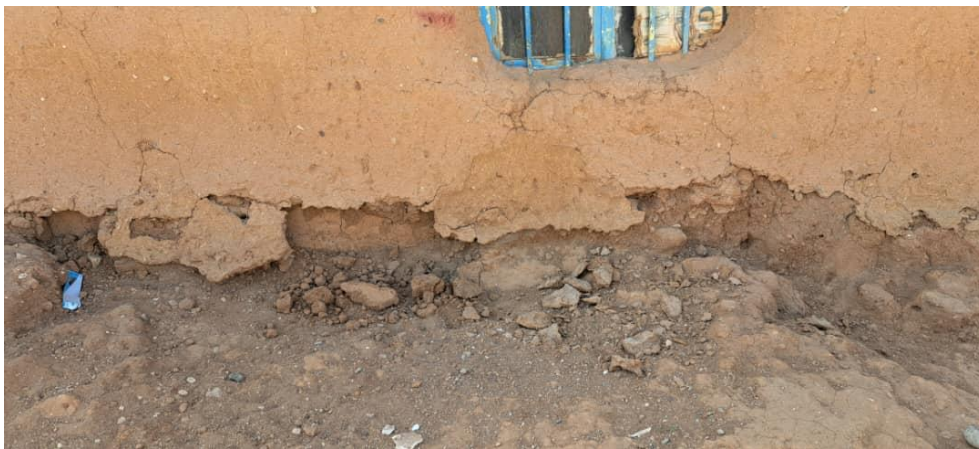
- It was observed during the assessment that both compound and house/room walls built with raw earth have no stone foundation and stone stem walls (see Figure 2). It was also heard during an interview with villagers that they cannot afford stones for foundation and stem/plinth walls. Some stone sources were located at an average distance of 7-10 km. The foundations and stem walls made of stone at the bottom of the raw earth walls are essential to prevent moisture from rising into the walls by capillarity. Excess moisture in raw earth walls reduces their mechanical capacity and increases vulnerability to earthquake damage.

Figure 2 No rock foundation and rock stem wall.

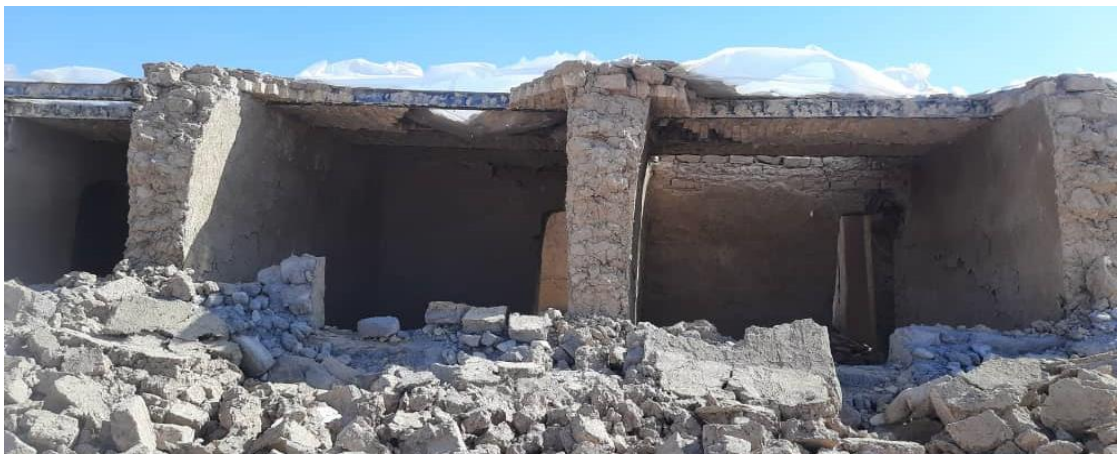
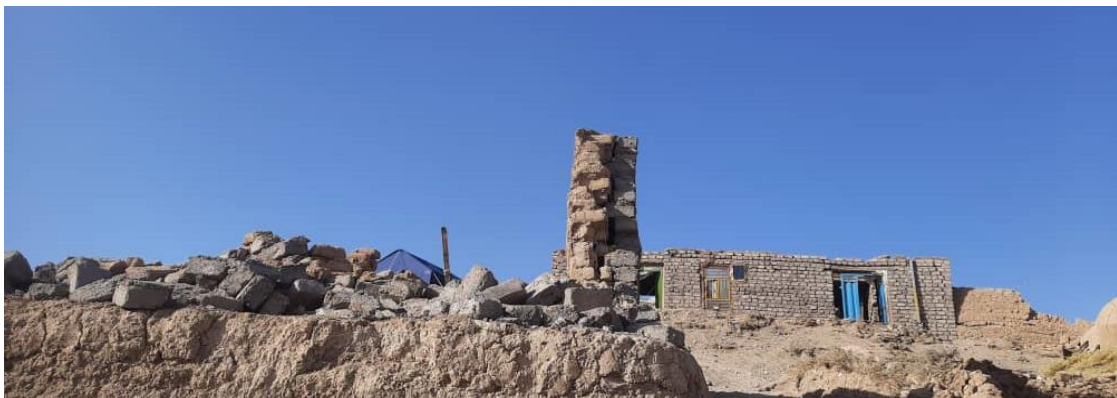
- Heterogeneous brick dimensions were used. This bad practice causes difficulty during bricklaying, which results in irregular and unstable walls.
 - In some walls, cement blocks were adjacent to *Khama-khashta*. Raw earth is a material that constantly regulates its humidity content in relation to the environment, which guarantees its structural qualities and environmental comfort. Cement has a high degree of impermeability; putting cement in direct contact with raw earth causes problems of excess humidity (see Figure 3).

Figure 3 Wall thickness at the lower part of the wall is thinner than its upper section, and cement blocks are used together with adobe.

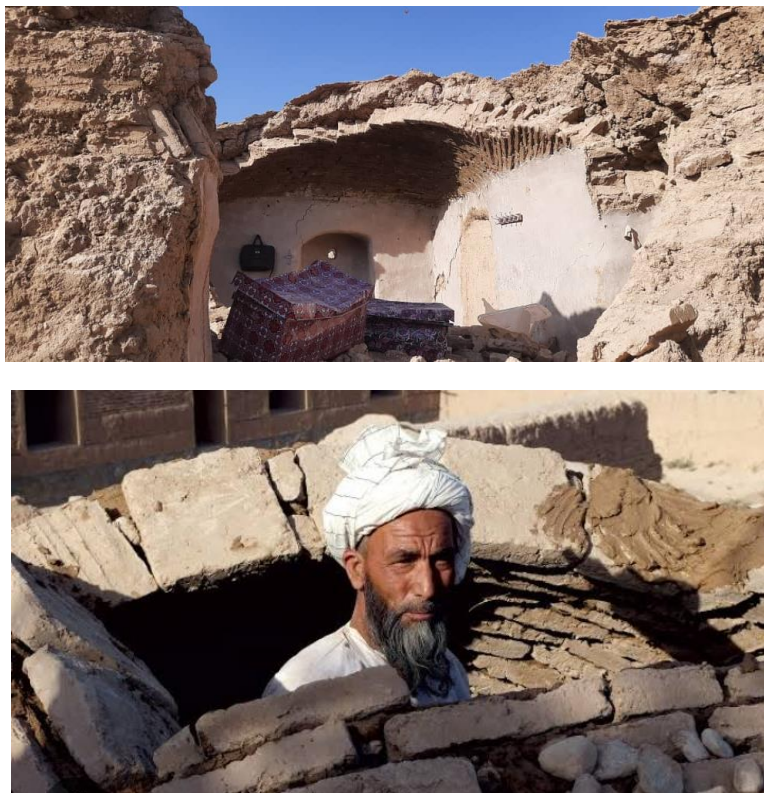
- The use of large-sized mud bricks (30 x 30 x 20 cm) with soil mortar poses a challenge in terms of cohesion between them.
- The thickness of such roofs reached 40 cm in some cases. This may be designed for waterproofing and thermal comfort; however, this thick material is heavy and creates high seismic mass which induces higher seismic damage to walls.

- The villagers stated that the domed roof construction process starts from all four sides of the rooms simultaneously without any shoring under them, thus the failure of such roofs is very common even during the construction process (see Figure 4).

Figure 3 Domed roof construction process.

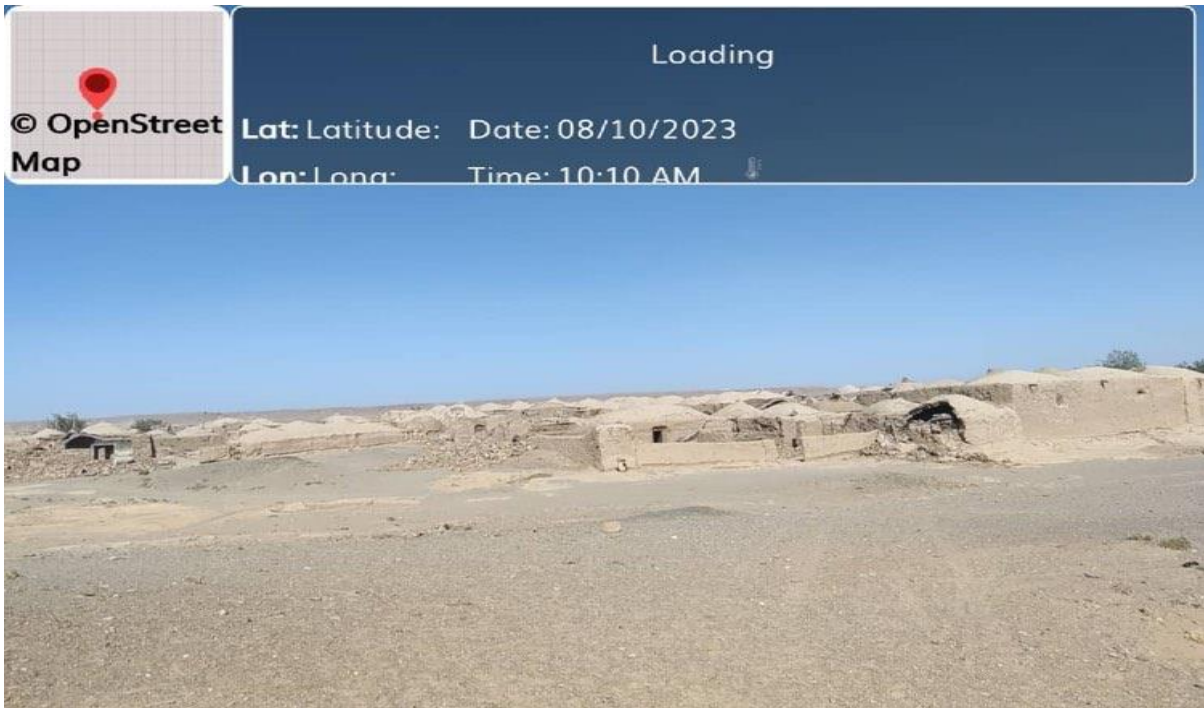
Figure 5 Cheshma Ghorri village.

Most of the houses in this village are traditionally made of raw earth with dome slabs constructed from *Khama-khashta*. The houses are partially damaged with less than 10 injuries and no loss of lives reported. However, second shocks increased the level of damage.

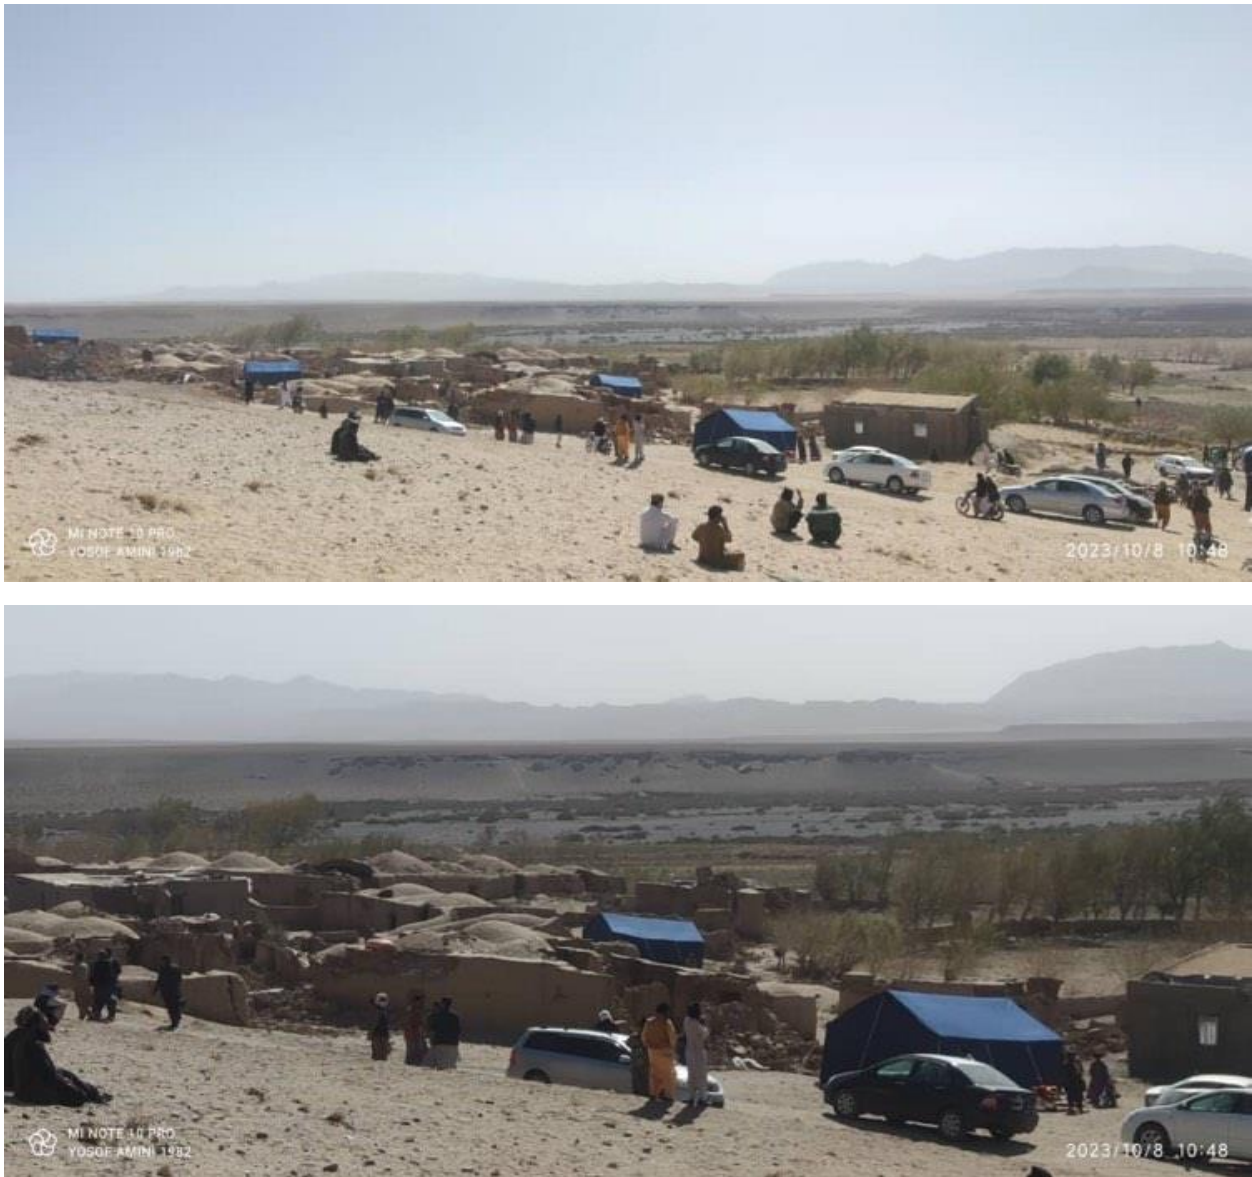
Figure 6 Sar Boland village.

The houses in this village are also traditionally made of raw earth with dome roofs. It was observed during the assessments that 60% of the houses were fully damaged while the remaining experienced partial damage. The village was visited after the second earthquake occurred on the 11th of October; the damage percentage increased to 90% of houses. The remaining 10% were not totally collapsed, but they had severe damage.

The casualties reported by some sources are 50% of the total population, while some interviewees said that 37 people lost their lives.

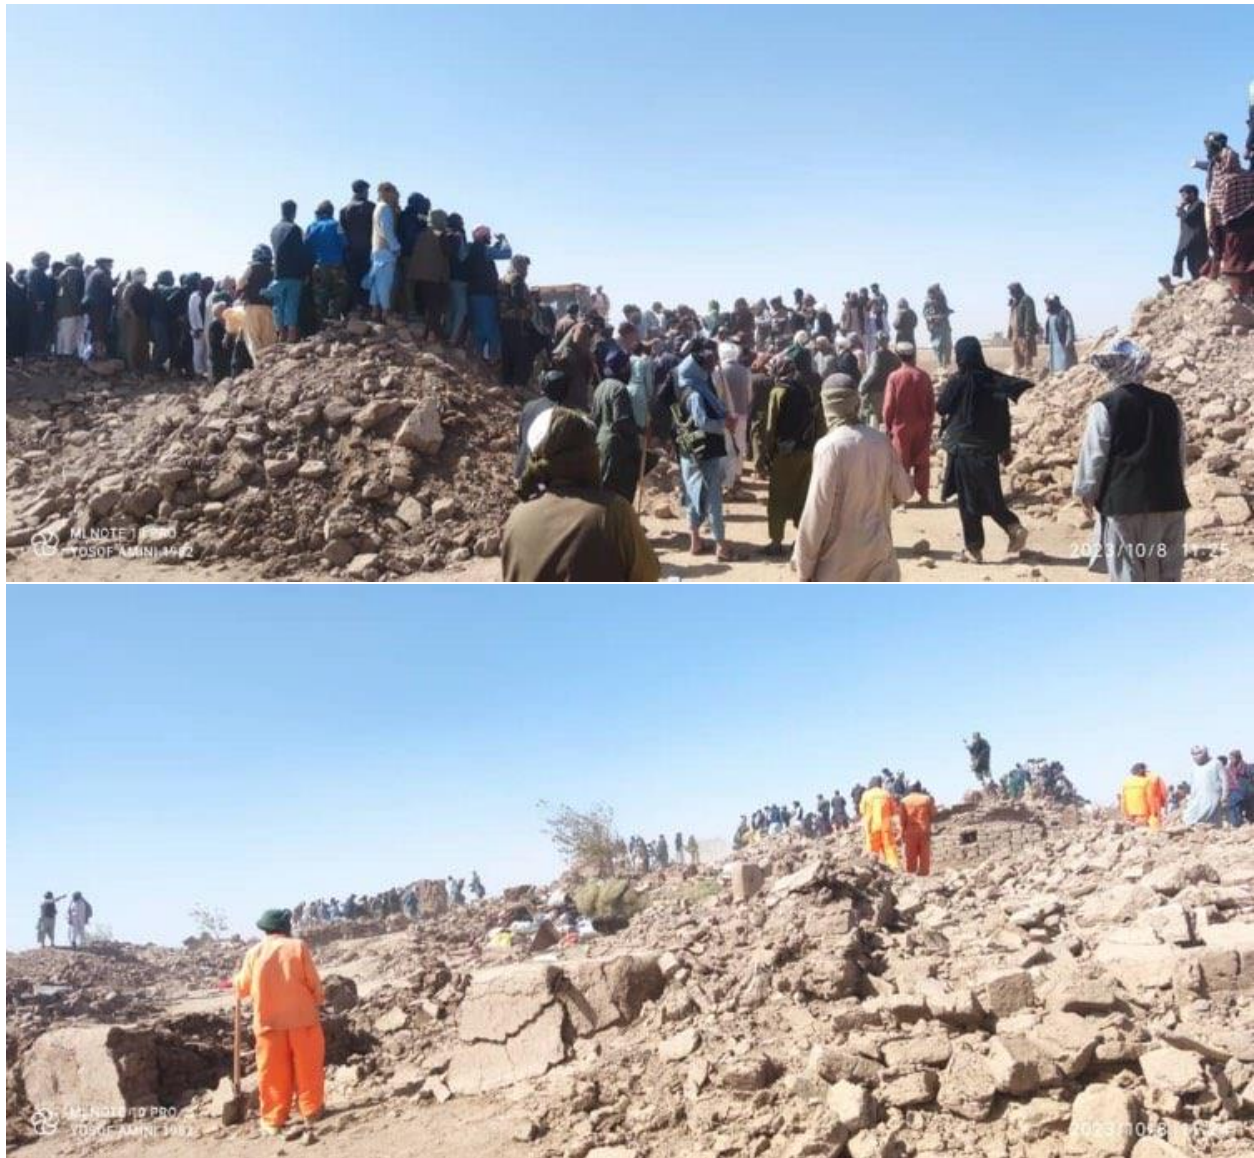
Figure 7 Nayeb Rafi village.

The typology of this village is similar to the two mentioned above. This village suffered extensive devastation. About 50% of its inhabitants lost their lives. The village is now in a state of complete collapse and disrepair.

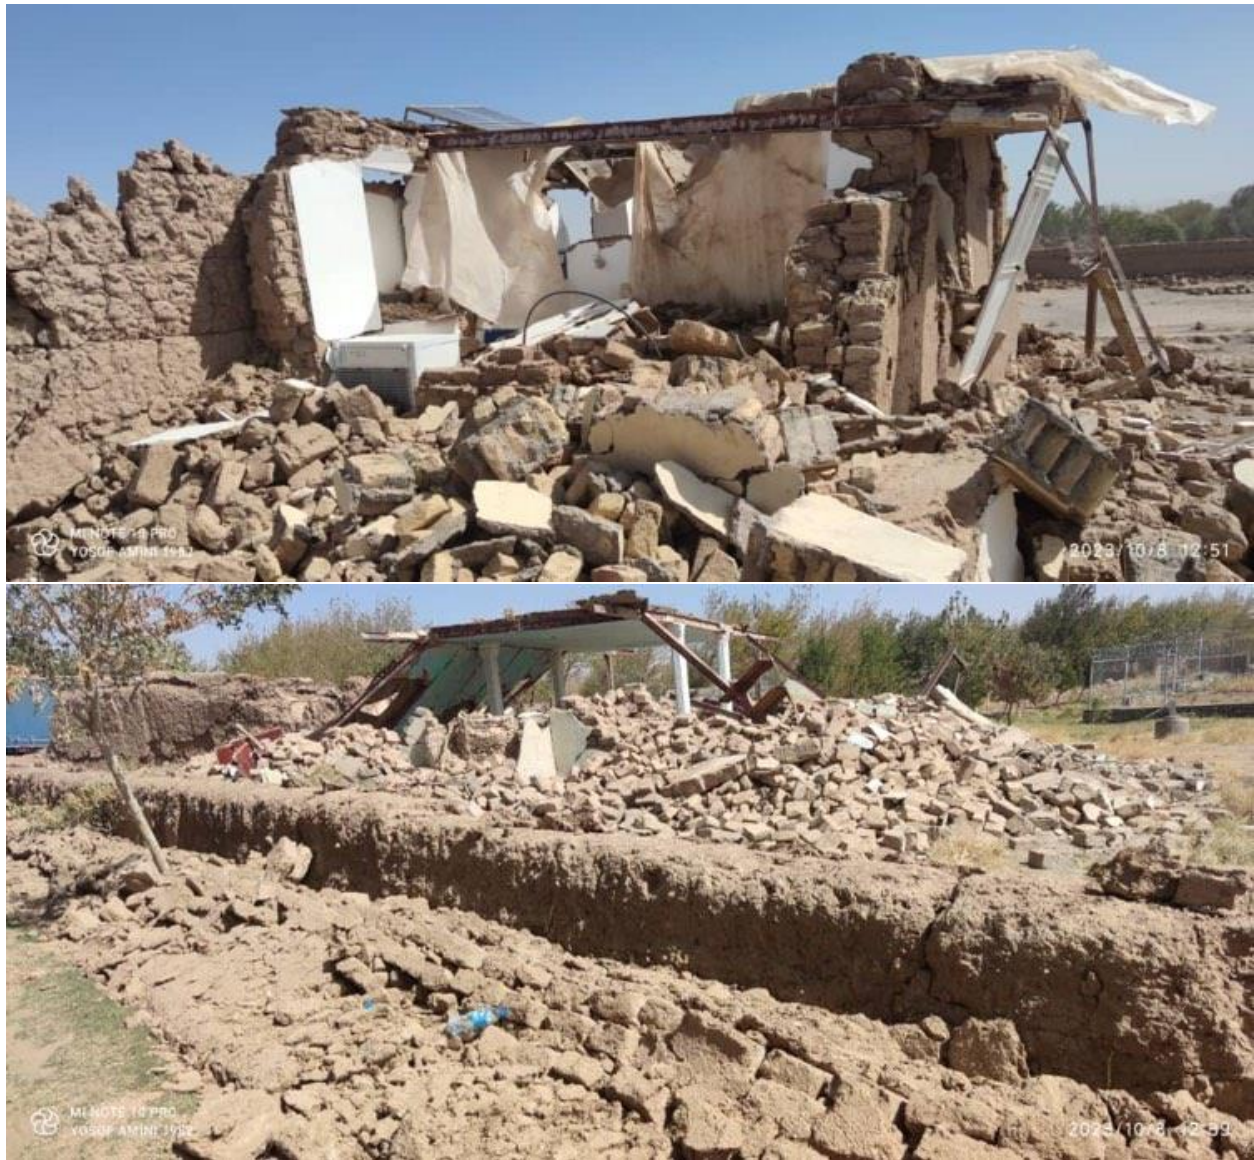
Figure 8 Wardak ha or Karnail village.

The houses in this village have the same typology as the villages stated above. In some areas, houses utilize steel I-beams with brick between them for roofs. This village witnessed the loss of approximately 24 lives. Similar to Nayeb Rafi, Wardak Ha has also experienced complete structural collapse and damage.

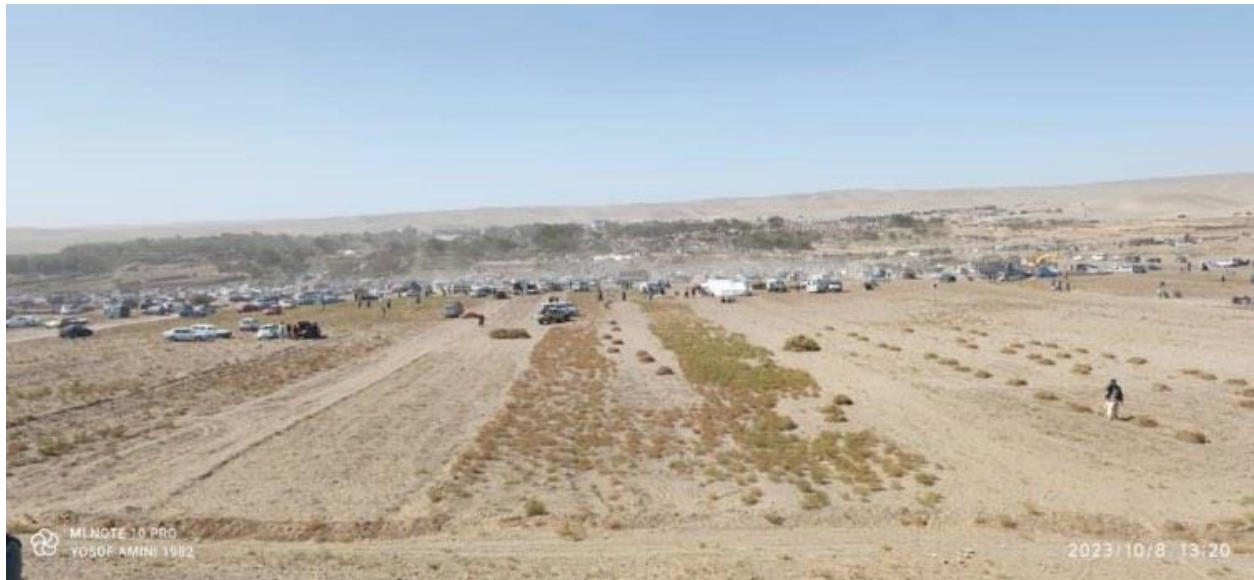
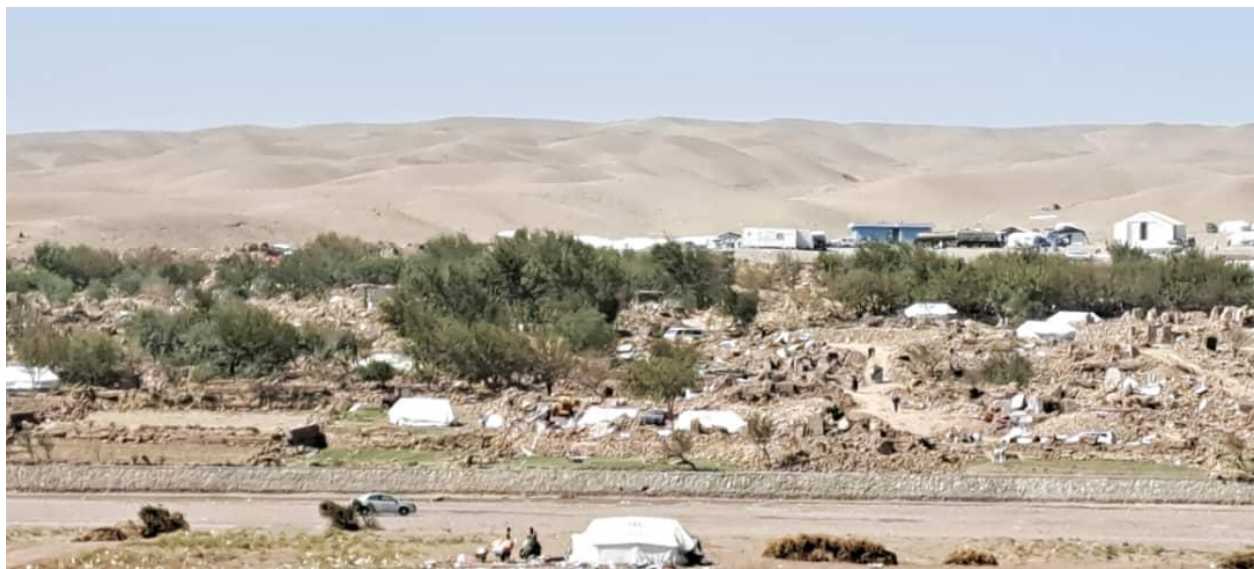
Figure 9 Sia Aab village.

This village saw around 40% (2,000 individuals) lose their lives. The village is now entirely in ruins due to the disaster's impact.

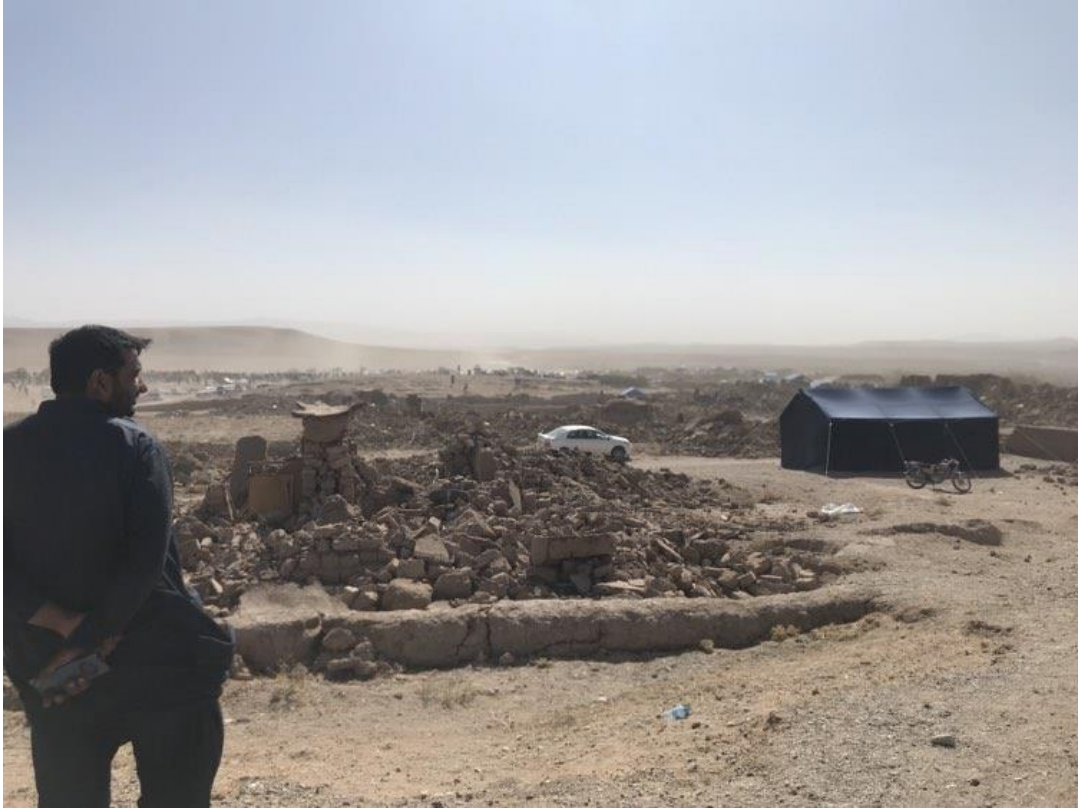
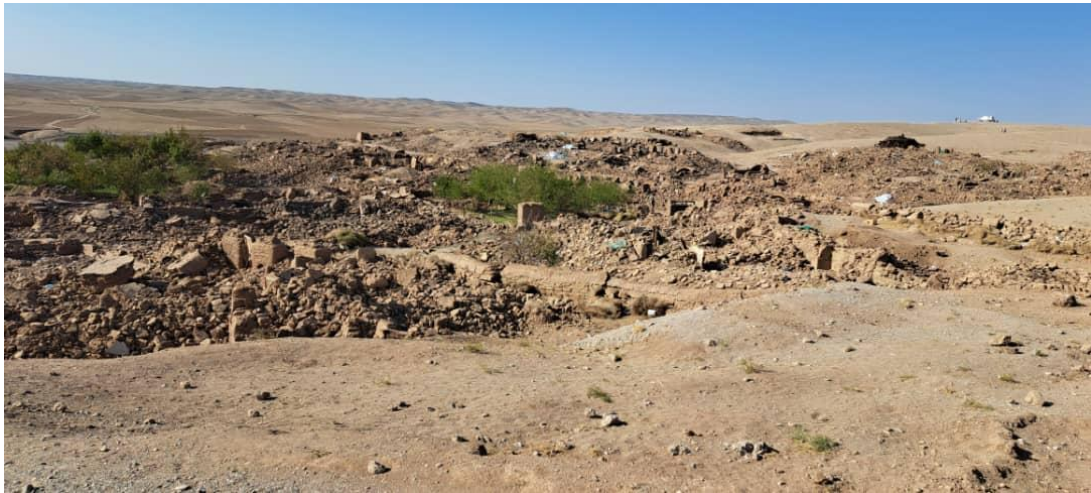
Figure 10 Maliki Ha village.

Maliki Ha suffered the loss of around 150 lives. A tragic incident occurred in Maliki, where 15 children lost their lives as a wall collapsed while they were studying under its shade. The village was found totally collapsed when visited for second time after the earthquake occurred on the 11th of October.
