# 2022 Southeast Afghanistan Earthquake, Rapid Technical Field Assessment Report

Kabul, Afghanistan | Structural Safety Study  
August 9, 2022

August 9, 2022

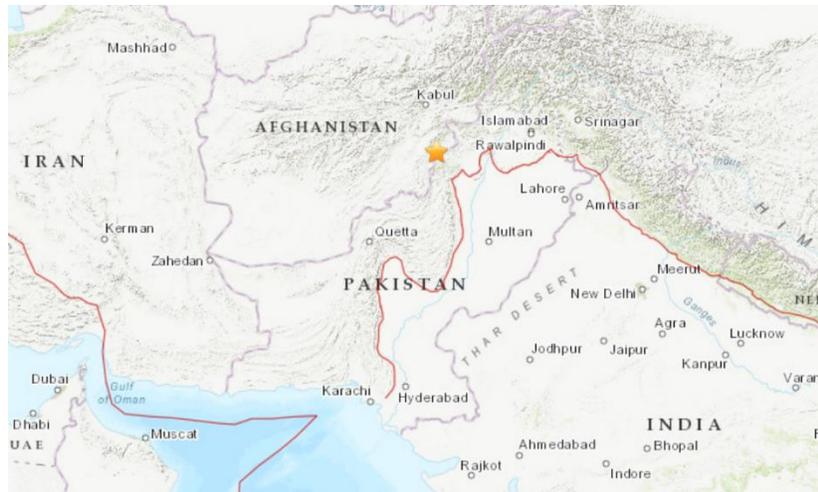
Figure 1-2. Tectonic setting of Afghanistan<sup>4</sup>.

Afghanistan is situated north and west of the subduction region resulting from the Indian plate subducting below the Eurasian plate. The Indian plate is generally moving in northerly direction and subducting below the Eurasian plate. The colliding plates result in buckling of the earth (Himalaya Mountains) and stresses building up within the rock layers; these stresses accumulate and are relieved by earthquakes<sup>5</sup>. **Figure 1-2** below illustrates the plate boundary (in red) and shows the proximity of the June 22, 2022, seismic event (star). For a full geotechnical assessment of the area, refer to the [Post-Earthquake Geotechnical Assessment report](#).<sup>6</sup>

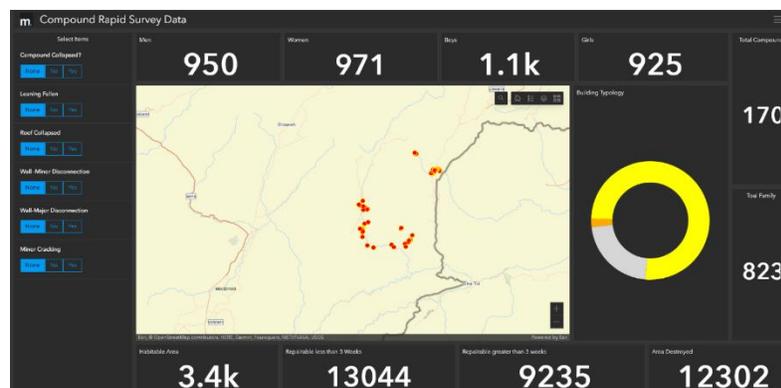
Figure 2-3. ArcGIS dashboard.

Following assessment, data is collated in ArcGIS which can be rapidly analyzed and sorted through the ArcGIS dashboard. **Figure 2-3** below is an example of the dashboard. A full copy of the survey questionnaire has been included in Appendix A. A total of 552 compounds were assessed. This included just under 12,786 people from 2310 families, with a total assessed indoor living space (including still habitable, damaged, and repairable or destroyed spaces) of 379,854m<sup>2</sup>, an average of 162m<sup>2</sup> of covered living space per compound prior to the earthquake. The assessment found an average of 4 families per compound, with an average family size of 5.5 people, which works out to 7m<sup>2</sup> of undercover living space per individual, or just under 39m<sup>2</sup> per family prior to the earthquake.

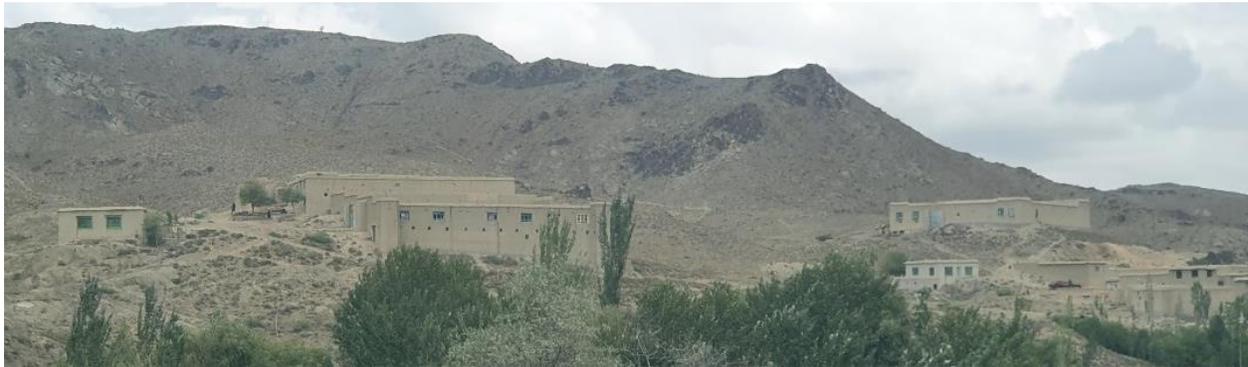
*Figure 2-4. Views across remote valleys in the region with few signs of introduced modern building materials.*

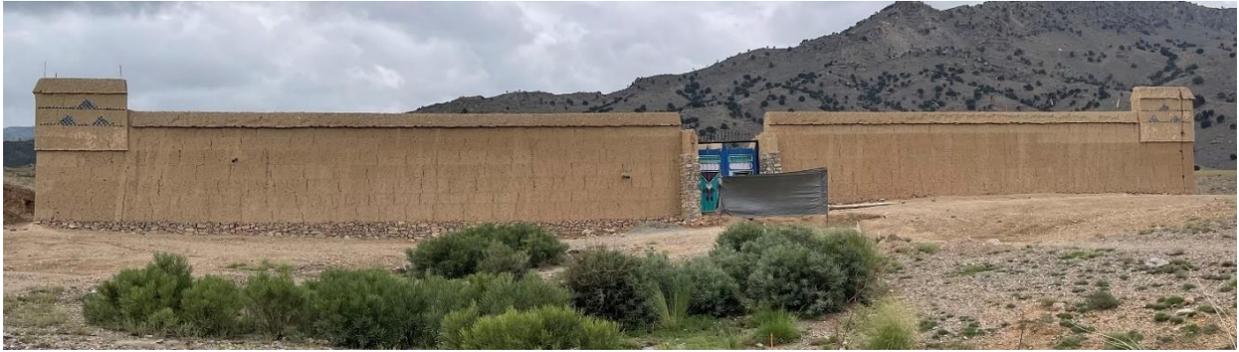
*Figure 2-5. Example of a large Pakhsa compound wall (5-6m high).*

*Pakhsa* is a vernacular construction practice that combines regionally available clay soils with small aggregates to form monolithic wall elements. Clay soils are hydrated with water and the batch is worked (mixed) to ensure mixing of the components that are then formed into lifts (layers) of approximately 50cm high. Hydration and batching processes vary based on local cultural practice and potentially related to variations in material quality. New layers are built upon the foundations or underlying supporting course (layer) and later trimmed. These wall systems are most commonly used for perimeter walls, as well as for courtyard-facing exterior room walls, and some interior partition walls. The typical wall height observed for perimeter walls was 3m to 5m (perimeter walls) with interior partition and courtyard facing room walls of 2m to 3m.

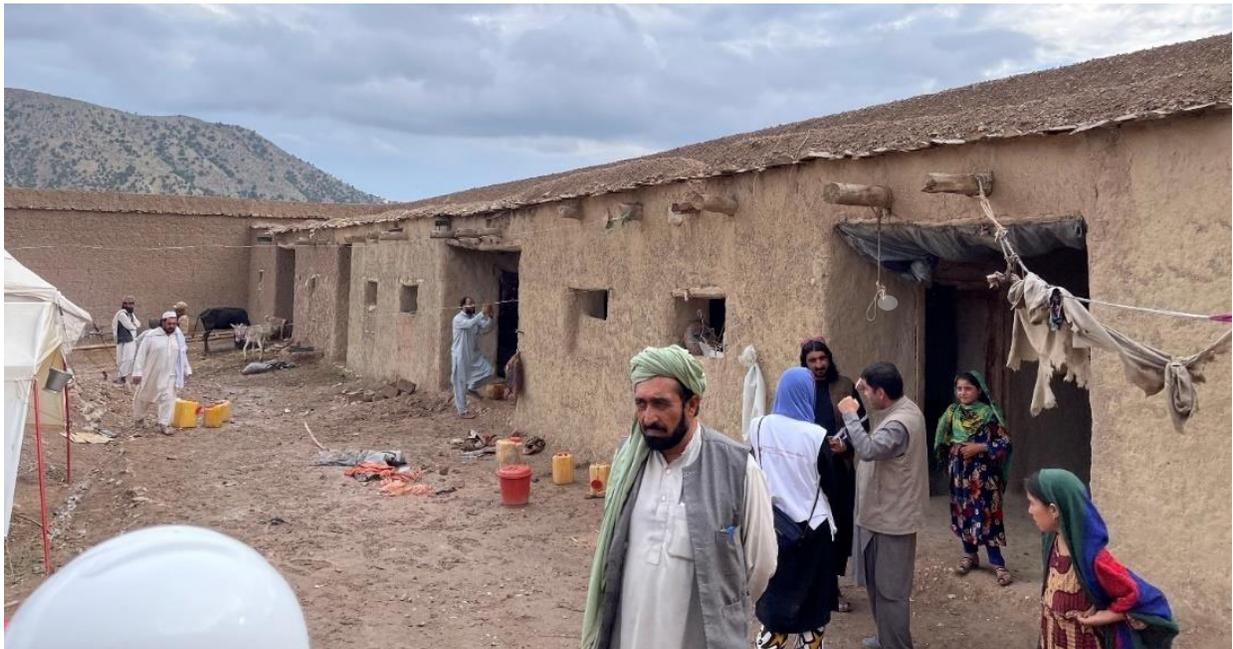
*Figure 2-6. Example of Pakhsa used for inner compound room wall construction.*

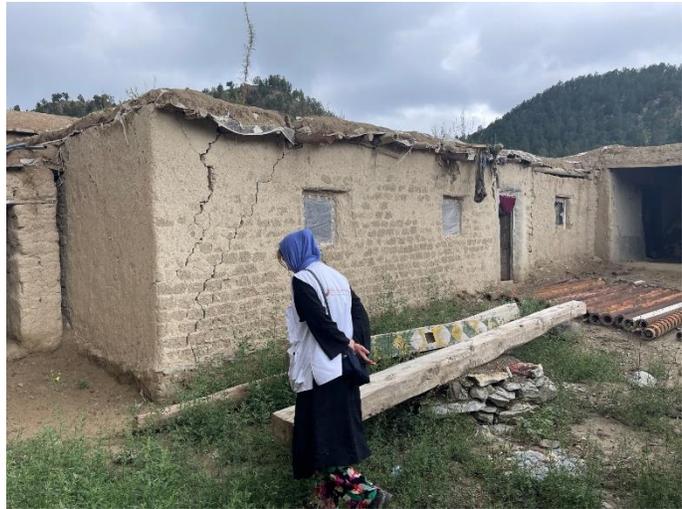
*Figure 2-7 Example of mud brick construction.*

Mud brick is a vernacular construction practice that combines regionally available clay soils with small aggregate to form regular rectangular block elements. The size of the blocks varies by location as does the composition of the block elements. Like *Pakhsa*, clay soils are hydrated with water and the batch is worked (mixed) to ensure consistency and then formed into the block elements. The bricks are then assembled in courses with differing thicknesses and used to support the roof system. **Figure 2-7** illustrates typical mud brick construction.

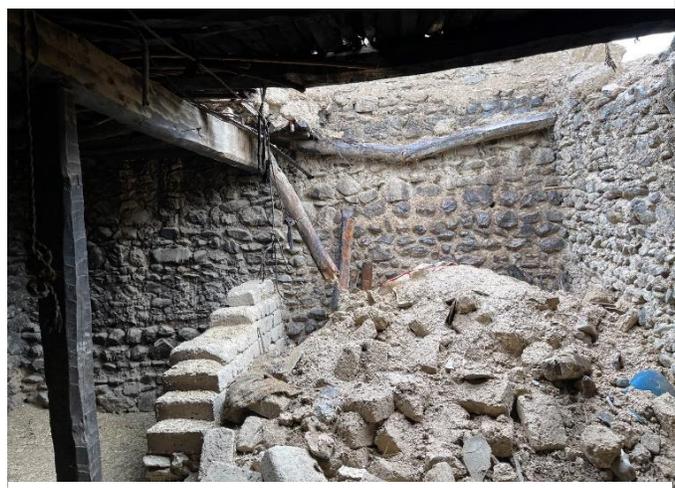
*Figure 2-8. Example of rock wall construction to the rear with collapsed mud brick rubble in front.*

**Figure 2-8** illustrates typical rock wall construction, in this case built with an interlocking clay-based mortar.

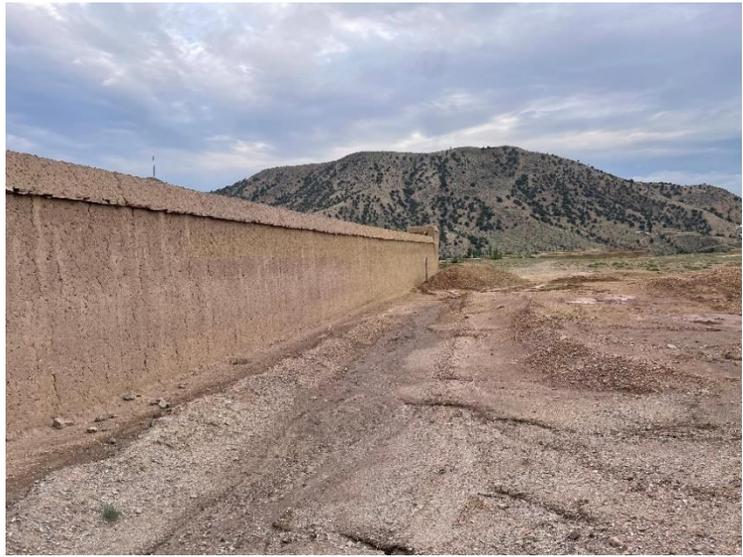
*Figure 2-9 Length to height ratio of Pakhsa walls*

Commonly in URM buildings the distance between orthogonal walls and the presence of the floor/roof connection makes the structure work as a box like element, when exposed to a seismic event. In those cases, band beams are necessary to connect the floors to the walls and orthogonal walls.

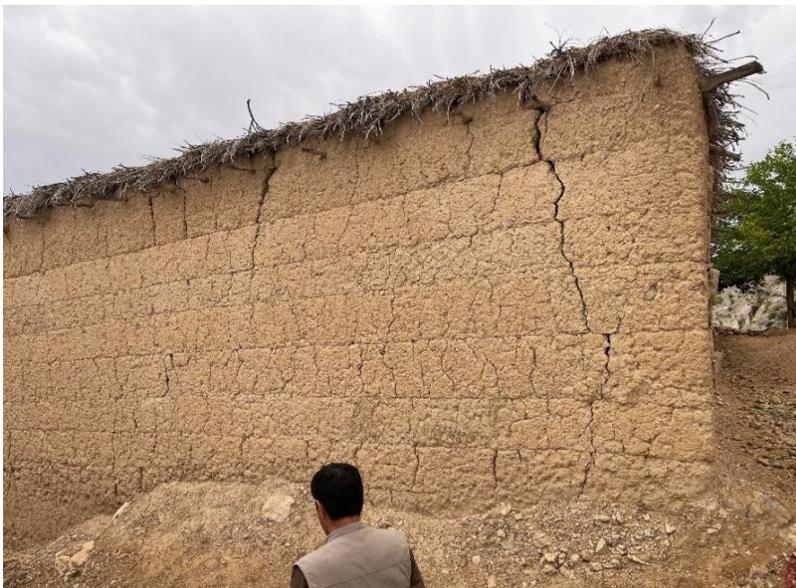
The shape factor in the *Pakhsa* compound walls produces a different behavior of the wall in the central part and close to the corners. In these last positions the cracks disconnect the two orthogonal walls that displace independently as illustrated in **Figures 2-10 and 2-11**.

*Figure 2-11 Example of commonly observed partial corner detachment.*

The evidence of rocking behavior during earthquakes is the probable reason behind commonly observed detachments at wall corners as seen above. ***In this case a strip band especially of rigid concrete or steel elements may significantly alter this structural behavior increasing the probability of structural instability and potential building failure.***

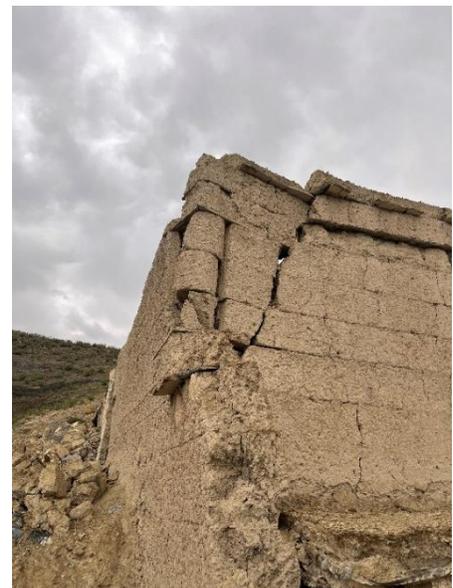
*Figure 2-10 Example 2 of corner detachment*

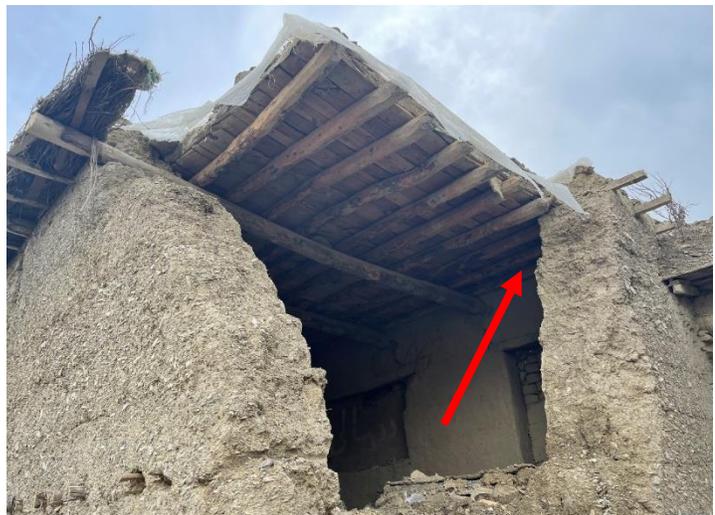
Figure 2-12 Example of Pakhsa wall construction

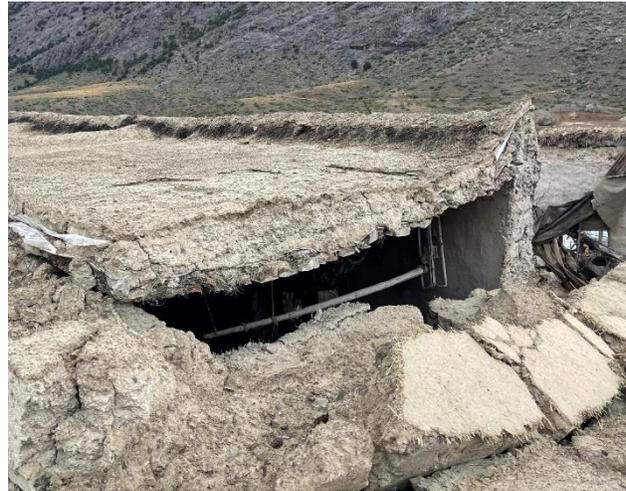
Roofs are commonly repaired prior to winter with additional layers of mud added to ensure adequate waterproofing and improve thermal comfort. Proper maintenance of the roofing systems should include regular removal of excessive mud and replacement of mud/timber where needed to ensure structural quality and adequate water protection. Many cases were observed where multiple layers of mud had accumulated over the years, resulting in excessive roof thickness and potentially unnoticed pest or rot damage to timbers. The weight of the mud roof system, particularly where multiple layers have been allowed to accumulate, contributes significantly to the seismic mass of these structures and is associated with reduced performance. Reference **Figure 2-13**.

*Figure 2-13. Failed section of multilayered roof.*

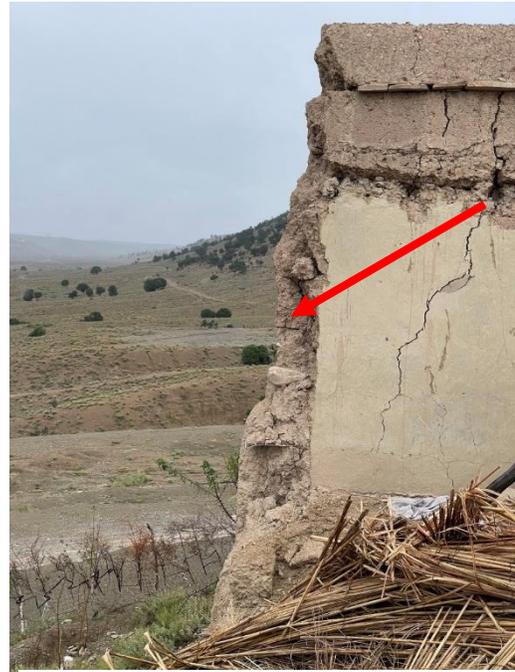
Figure 2-14. Failed section of Pakhsa wall

Retaining walls are used to support earth and allow a sloping site to be leveled. Retaining walls are commonly exposed to high water loads and changing hydrological pressure, which unstabilized clay structures are unable to withstand. As such, *Pakhsa* walls are inappropriate for this application and rock walls should be used with a mass retaining approach. *Pakhsa* walls can then be supported on top, ensuring the *Pakhsa* system itself has adequate drainage and does not bear any retaining load.

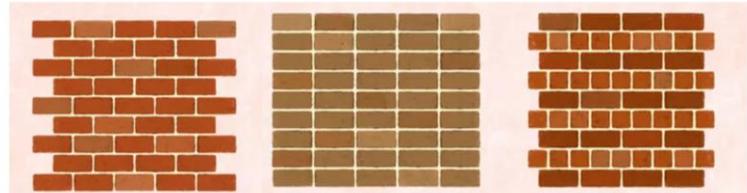
Figure 2-15. Examples of Stretcher, Stacked and English Bond coursework.  
Source: spruce.com

Masonry systems generally utilize unitized rectangular units that are laid in a pattern to form a wall. The way the masonry units are laid is commonly referred to as the bond. The coursing or bond pattern utilized varies in type and size of the masonry unit, wall dimensions and other project factors. The most commonly used pattern is a Stretcher or Running Bond where bricks are laid longitudinally overlapping midway between courses. Best observed practice used double layered walls with alternating courses of Stretcher and Bond courses known as an English Bond. In some cases, a Stacked Bond pattern (aligning of the blocks vertically) was observed, which unless otherwise reinforced, is associated with reduced performance. In addition, poor quality or missing mortar (additional discussion in the following section) contributed to weak wall structures. **Figure 2-16** illustrates an example of poor course work.

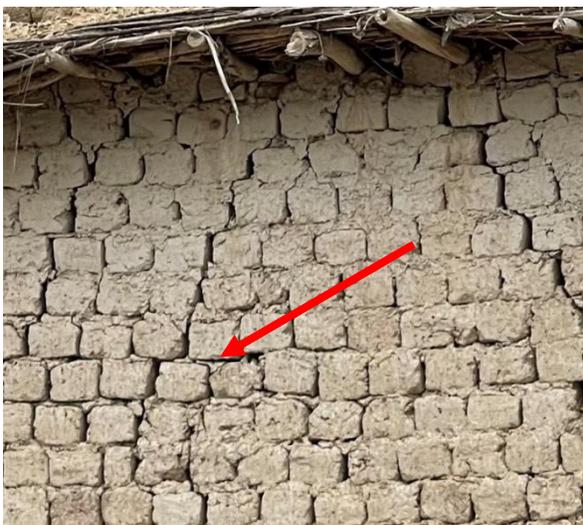
In addition to incorrect coursing, **Figure 2-16** illustrates poor mortar joints including incomplete head and bed joints. The head (sometimes referred to as perpendicular joints) refers to the vertical joint between adjacent masonry units. The head joints maintain space between the masonry units and help make the wall act as one. When the head joints are incomplete, it allows masonry units to shift and can lead to an incomplete gravity load path resulting in failure, reference **Figure 2-17**.

Figure 2-17. Example of insufficient coursing.

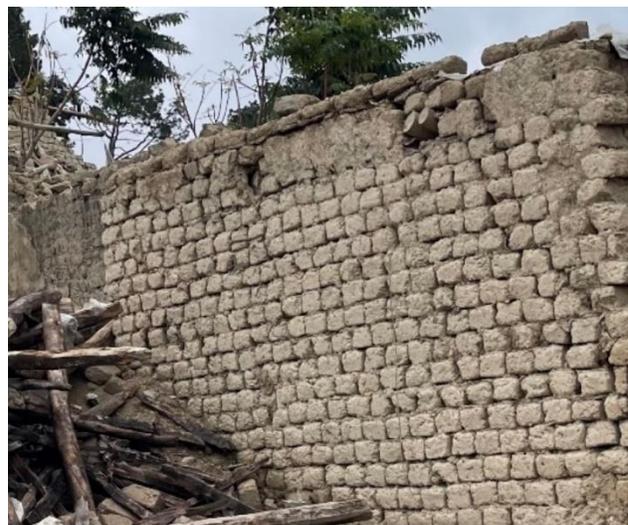
Figure 2-16 Example of poor mortar joints, poor rain protection and poor course work.

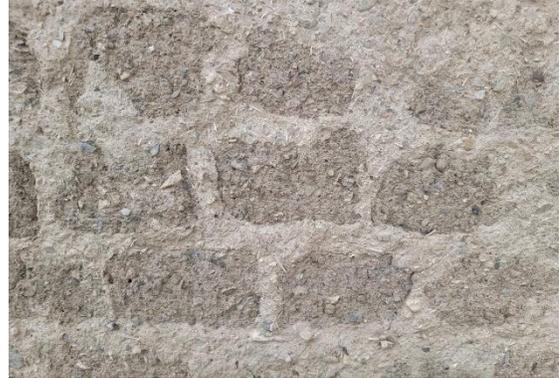
Due to the small unit nature of the mud brick system, erosion and water protection were noted as critical to performance. When the mud brick system isn't protected from water, the units and mortar were noted to deteriorate with significant structural implications. The traditional solution for this is the application of a mud-based plaster that provides protection. Wall systems with maintained plaster were observed to perform better than those lacking plaster. **Figure 2-18** illustrates plaster wall protection.

*Figure 2-18. Example of plaster protecting mortar.*

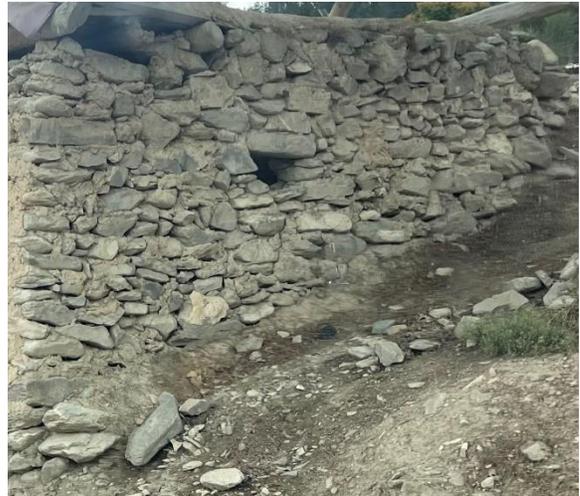
Rock walls utilize locally available rocks and the shape/form of these varies regionally. In some cases, they are round river rocks while in other locations they are flatter and angular. In general, wall systems with angular rocks assembled to provide a cohesive wall and bound by mortar have better performance. **Figure 2-19** illustrates an example of angular rock construction.

*Figure 2-19. Example of angular rock wall construction.*

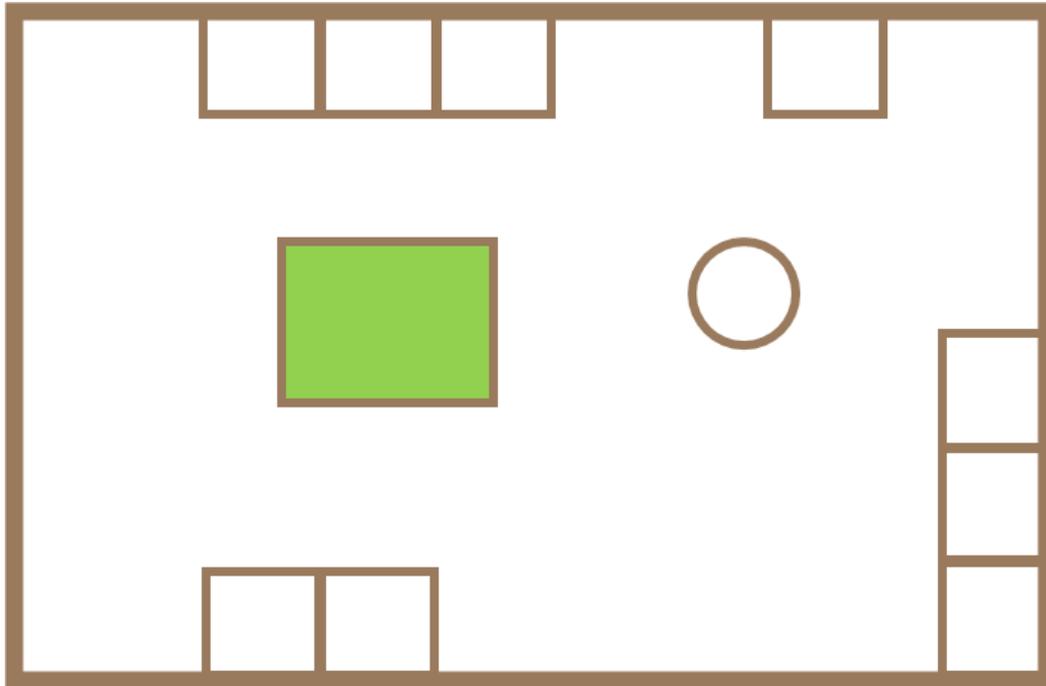
The predominant housing form encountered during the field assessment was that of a series of rooms contained within a larger family compound. Commonly, these compounds were owned by a senior male member of an extended family group with his sons and their families occupying rooms within the compound. Some compounds also housed more distant relatives, and many also included rooms for guests either inside or outside the compound walls. Although some freestanding houses were observed, these did not appear to be as common<sup>12</sup>, though this did vary from region to region and certainly appeared more common in denser more urban environments.

*Figure 3-1. Example of the typical layout of a compound.*

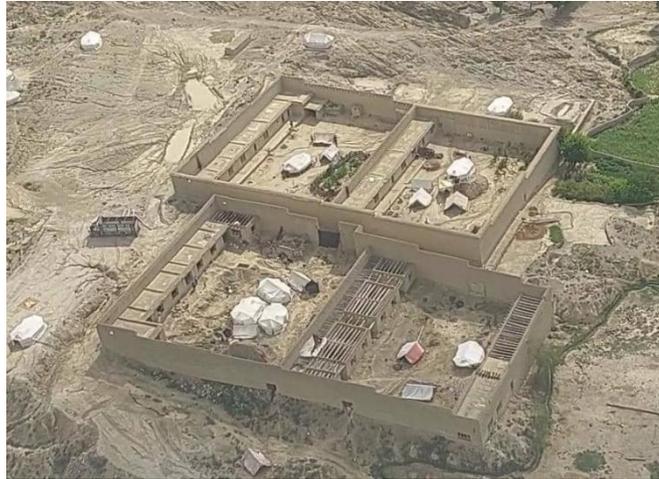
While in some ways the compound is the primary housing unit, it also usually contains multiple families, occupying rooms that compromise their individual home within the extended family compound. The exact relationship between numbers of rooms and households within a compound is not fixed. Each of the compounds shown in **Figure 3-2** may house only one or possibly four or more families.

*Figure 3-2. Four compounds as seen from the air. Note the construction of rooms along the perimeter wall with open spaces in the middle. Photo courtesy of Jago Boase, IOM.*

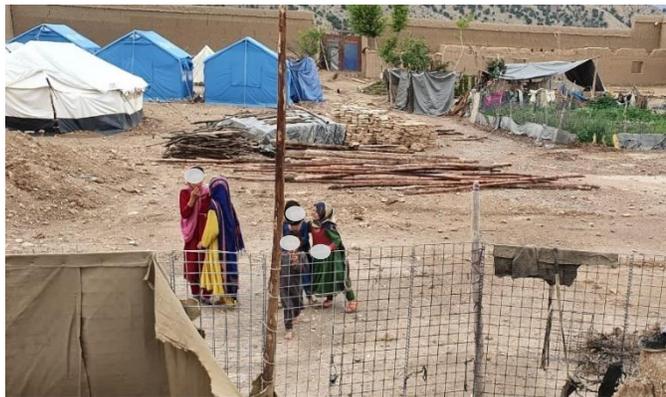
*Figure 3-3. View inside a compound, note the repairable rooms to the top right and that women are confined to the tents visible top left.*

Reconstruction of compound walls is a key protection issue for women in the compound. Without the compound wall, women are not free to move around outside where they could be seen and must remain in tents or small rooms for extended periods. Allocating funds both for temporary emergency privacy screening, and more specifically for repairs to compound walls, may have a significant impact on the lives of women<sup>15</sup>.

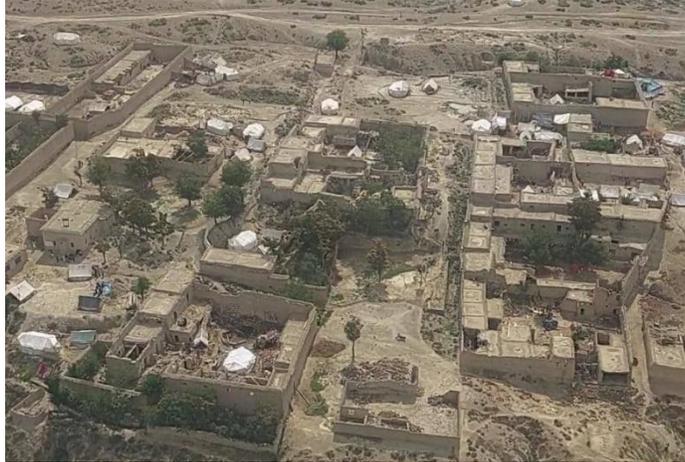
*Figure 3-4. Additional example of compound configurations as seen from the air. Note the limited number of non-compound housing. Photo courtesy of Jago Boase, IOM.*

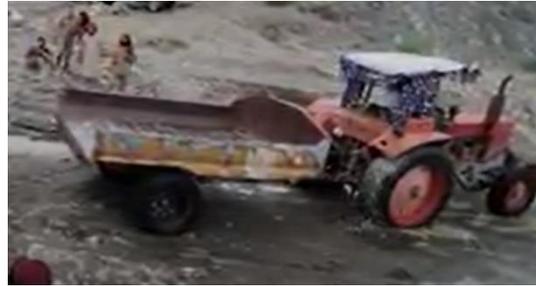
The June 2022 earthquake occurred in an extremely remote area with limited transportation access or shops. Most of the materials used in construction are either gathered on or near the site. The field assessment teams saw very little evidence of construction materials brought in from the external sources other than the occasional steel beam, windows, or doors. While direct cash assistance remains the preferred assistance modality, additional assistance may be required. The following considerations are critical

*Figure 4-1. Example of local tractor/trailers used to transport building materials.*

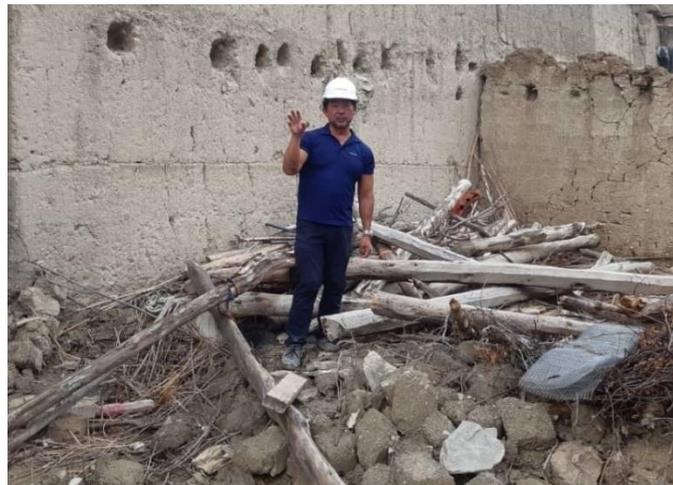
*Figure 4-2. A high volume of salvageable timber at an assessed site.*

- **Importing of additional timber.** While nearly all sites visited had sufficient timber for the construction of emergency shelters, in some cases this used a significant proportion of the household's salvaged materials, potentially impeding future recovery plans. Supply of some timber may help address this concern and reduce pressure on local deforestation.
